UPPER WALLACE DAM

VA. NO. 01516

# PHASE I INSPECTION REPORT

**JULY 1980**

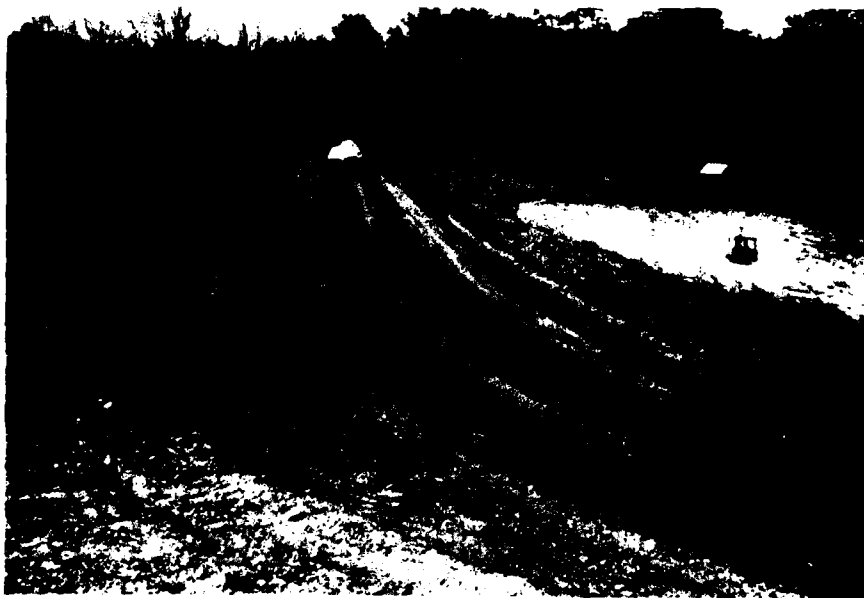
(Looking Across Dam)

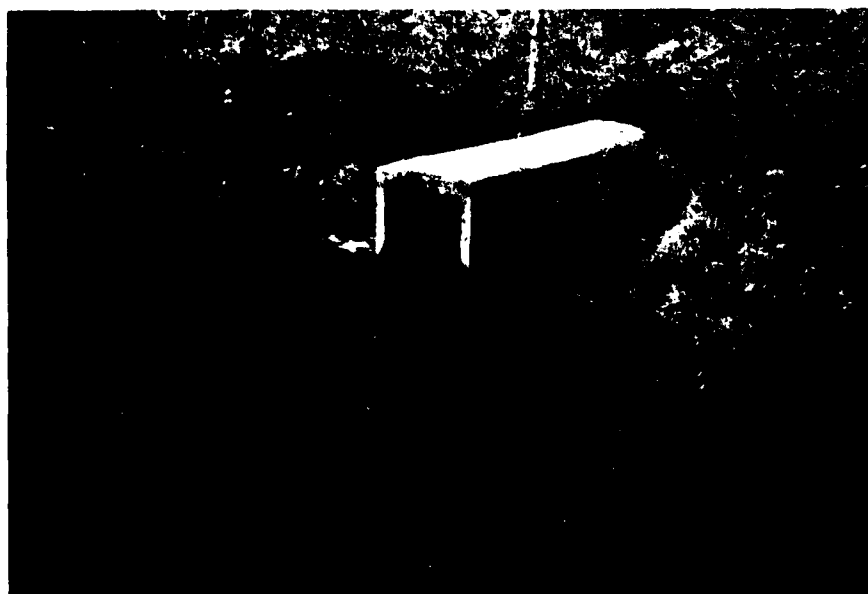
Photograph No. 2

Some erosion was observed around the outlet pipe (principal spillway). The downstream slope (1.7H:1V to 2H:1V) was well vegetated and essentially free of erosion. The steeper upstream slope (1.5H:1V) was not as well vegetated and included numerous steeply eroded gullies up to 2 ft in depth. These gullies generally occurred from 3 to 5 ft above pool level down to the lake. One groundhog hole was observed approximately 10 ft below dam crest and 100 ft<sup>±</sup> left of the right abutment.

Outlet Pipe (Note Erosion Around Plunge Pool and Pipe)

The outlet pipe and intake structure are in good structural condition. Erosion at the outlet pipe plunge pool should be corrected. The drain on the intake structure is in need of repair. The emergency spillway should be reseeded to establish a good vegetative cover and the roadway across the emergency spillway should receive a surface which will inhibit erosion.

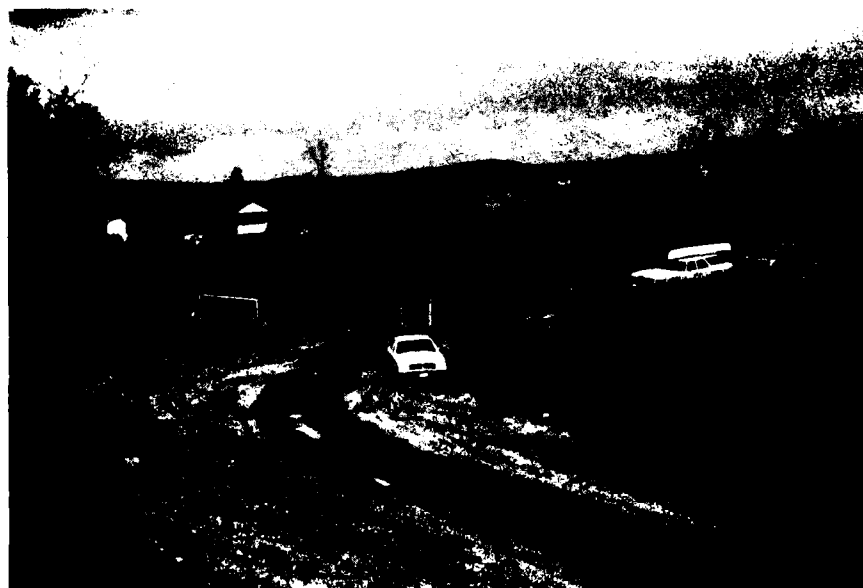
Emergency Spillway (Note Lack of Vegetation)  
Photograph No. 4

- 3) The emergency spillway should also be reseeded to establish a good vegetative cover.

7.3.4 The roadway across the emergency spillway should receive a surface which will inhibit erosion during overflow conditions.

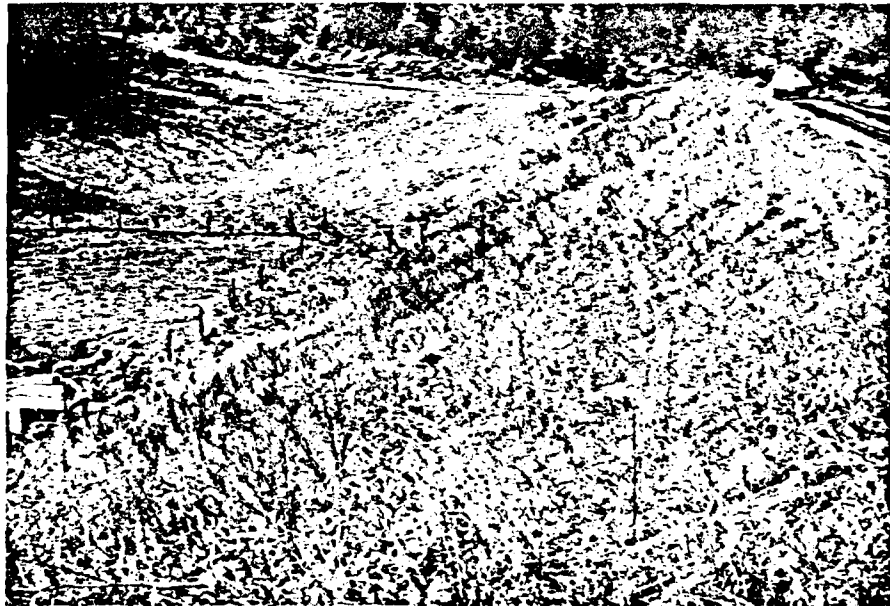
Photograph No. 6

The wet spots and iron-stained seepage encountered along the downstream slope represent seepage through the dam. No turbidity was noted during the inspection. This does not present a hindrance to the normal functioning of the dam, however, it is recommended that the seepage along the downstream slope be monitored quarterly to detect any increase in flow rates which may cause piping within the embankment. If increased flows should occur, a Professional Engineer with expertise in Geotechnical Engineering should be contacted to evaluate the problem and make recommendations for required corrective measures.

Downstream Face of Dam

7.3.1 Seepage present along the downstream toe should be monitored quarterly to detect any increase in flow rates which may cause piping within the embankment.

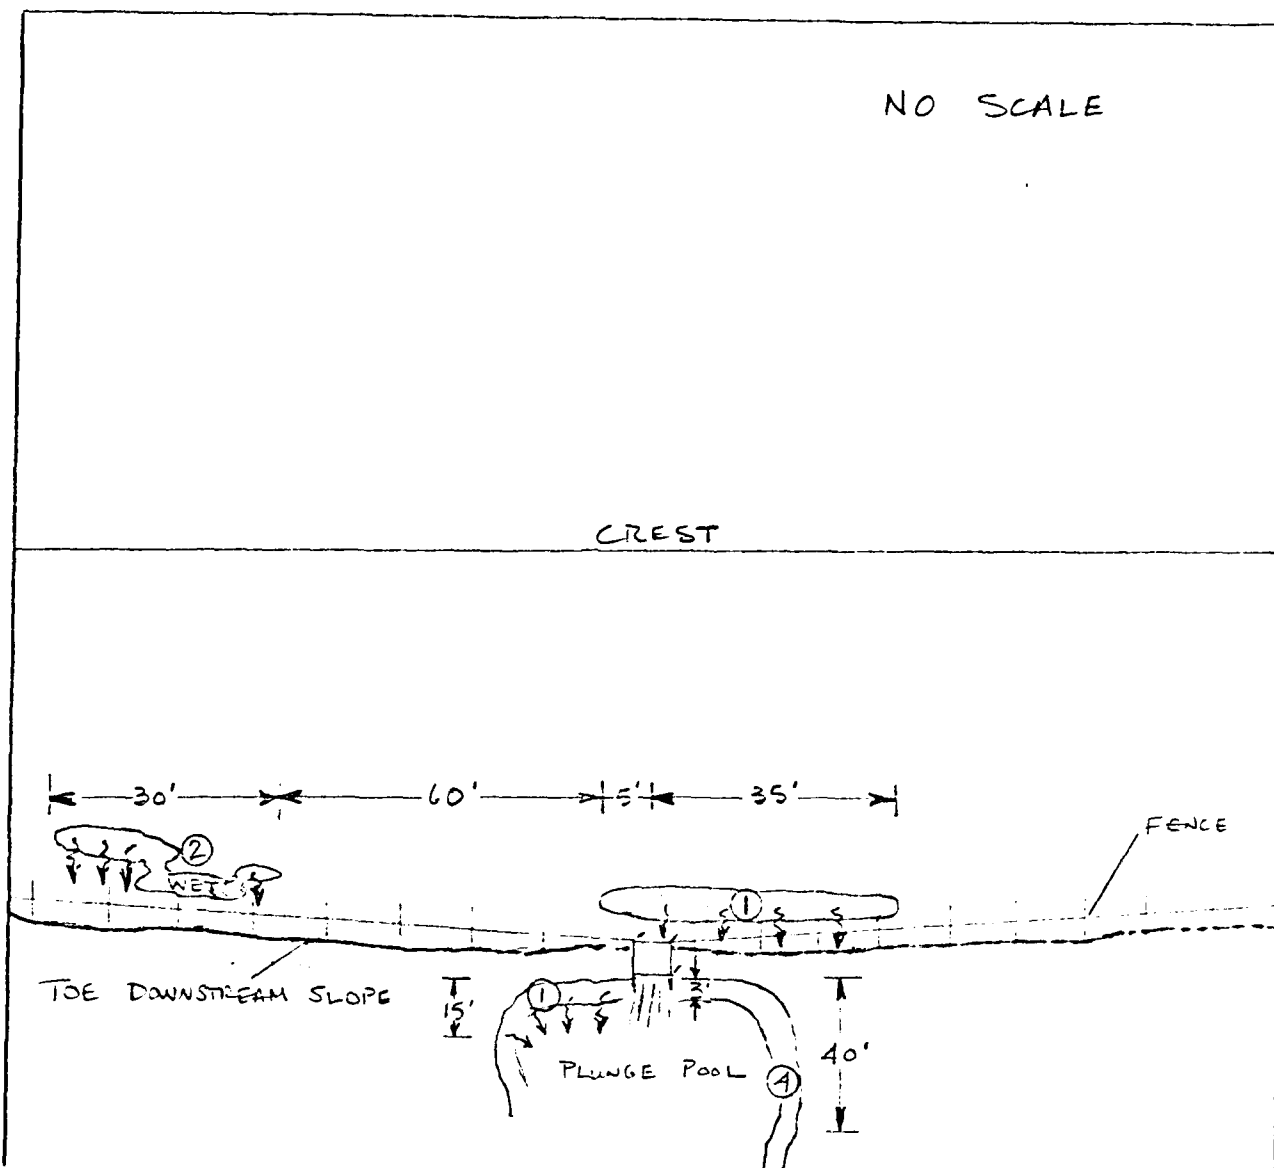
SUBJECT FIELD SKETCH — SEEPAGE AREAS, UPPER WALLACE DAM

3.1.2 Dam and Spillway: The downstream and upstream embankment slopes and portions of emergency spillway were grassed (1 to 2 ft high) and included scattered cut brush and briars. Seepage was observed along the downstream toe in two general areas. One area consists of saturated ground extending to a point 35 ft± left of the outlet pipe and varying from 2 to 5 ft± above the pipe. Some iron staining was present, but no flow was observed. Another area consisted of two coalescing wet spots located from 65 to 95 ft± right of the outlet pipe and from 3 to 9 ft± above the pipe. Again, the ground was saturated, but no flow or iron staining was observed. Seepage and heavy iron staining were observed along the plunge pool. Flow estimated up to 1 gpm and iron staining were noted in a 15 ft wide area immediately to the right of the outlet pipe, along the 3 ft± high perimeter slope of the pool. Intermittent iron staining was also noted in a 40 ft± long section of the left side of the plunge pool from

- ① SEEPAGE 2 TO 5 FT ± ABOVE TOP OF OUTLET PIPE, SOME IRON STAINING, NO FLOW OBSERVED. GROUND SURFACE ON DOWNSTREAM SIDE OF FENCE ALSO INCLUDES SATURATED AREAS.
- ② THIS AREA CONSISTS OF TWO WET SPOTS WHICH COALESCE AT TOE OF SLOPE. THE LOWER SATURATED AREAS EXTEND 3 TO 5 FT ± ABOVE THE TOP OF OUTLET PIPE, WHILE UPPER AREA IS ABOUT 9 FT ± ABOVE. NO IRON STAINING OR FLOW OBSERVED.
- ③ SCATTERED SEEPAGE IN 15 FT ± WIDE AREA ALONG VERTICAL SLOPE, IRON STAINING, FLOW UP TO 1 GPM ±
- ④ INTERMITTENT IRON STAINING ALONG EDGE OF PLUNGE POOL

7.2.1 The Owner should engage the services of a qualified Professional Geotechnical Engineer to perform a subsurface investigation and stability analysis in order to evaluate the stability of the dam and modify as necessary. The widespread seepage observed along the downstream slope should be assessed in this study.
